Failure analysis of austenitic stainless steel AISI 304 Exhaust bag filter at Sanati Dodefam Co.

¹KADFA Company, Ahvaz, Iran

²Sanati Dodefam Company, Dezful, Iran

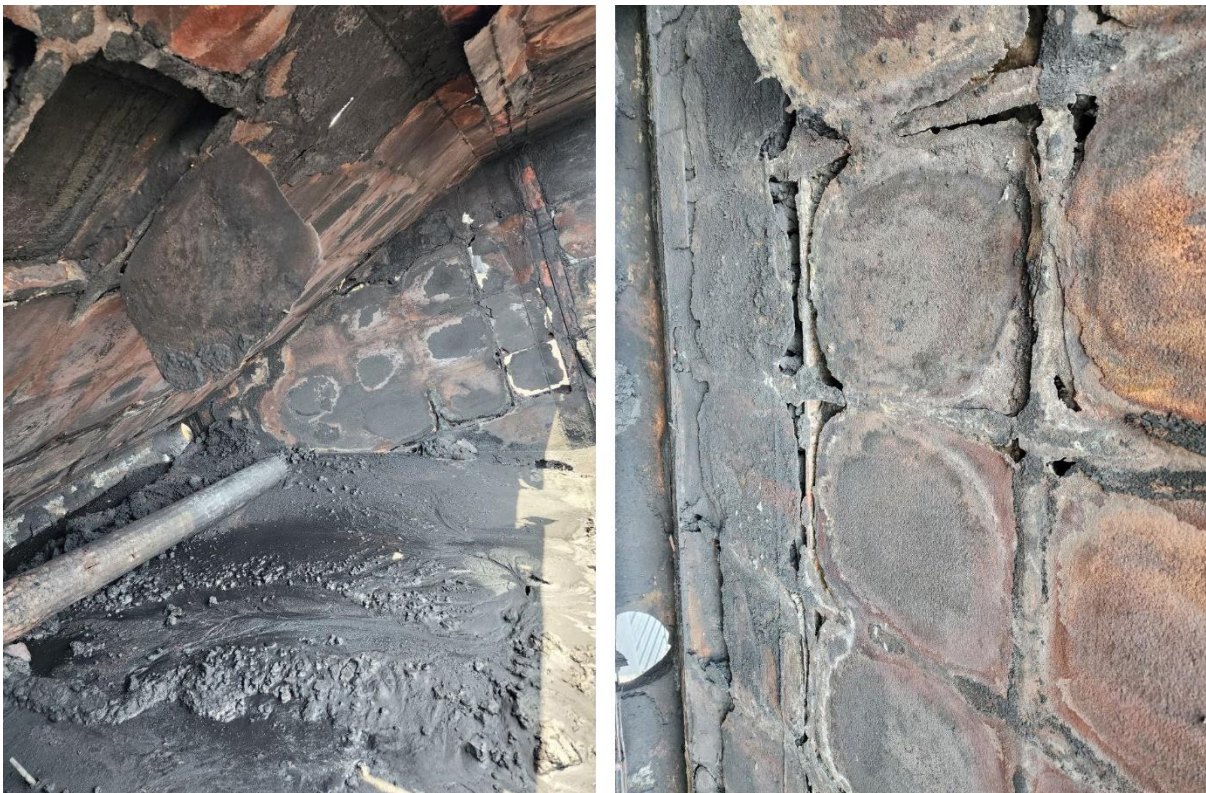
Field inspections uncovered severe corrosion on the body of the exhaust bag filter (Fig. 1), with characterized by significant thickness reduction and multiple cracks. Corrosion was particularly pronounced in the welded regions. Analysis of the Process Flow Diagram (PFD) provided by the company indicated that the inlet gas consisted of hydrocarbons and water vapor at a temperature of approximately 240 °C. Armed with this data, various hypotheses were formulated to guide the design of the tests and analyses, aimed at pinpointing the cause of the failure.

Fig. 1. Failed exhaust bag filter with severe corrosion.

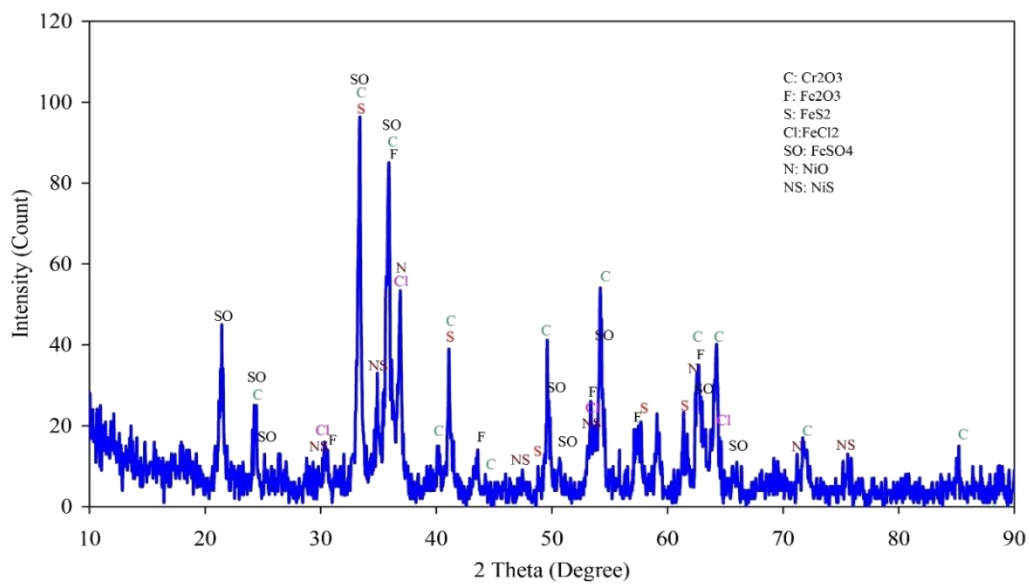
Fig. 2. XRD pattern of the corrosion products.

The XRD pattern of the corrosion products, depicted in Fig. 2, reveals Fe_2O_3 as the major component, with Cr_2O_3 and other oxides as minor constituents. The detection of chromium oxide suggests the detachment of the protective oxide layer from the stainless steel due to corrosion. Consistent with the XRF findings, peaks corresponding to sulfur and chloride compounds are evident in the XRD pattern.

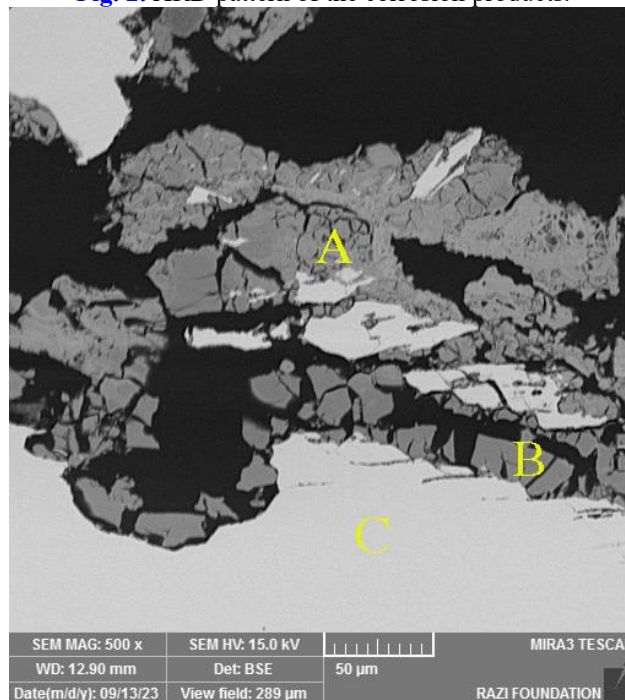
Fig. 3. SEM image of the sample cross section and corrosion products.

Owing to the localized nature of SEM images, multiple samples were examined, with the summarized results as follows. Elemental analysis (EDS) of the sample's cross section, illustrated in Fig. 3 and Table 3, indicated the presence of iron and chromium oxides (based on the percentages of oxygen, chromium, and iron) at point B in Fig.3. The chemical composition at point A closely matched that of the AISI 304 stainless steel.

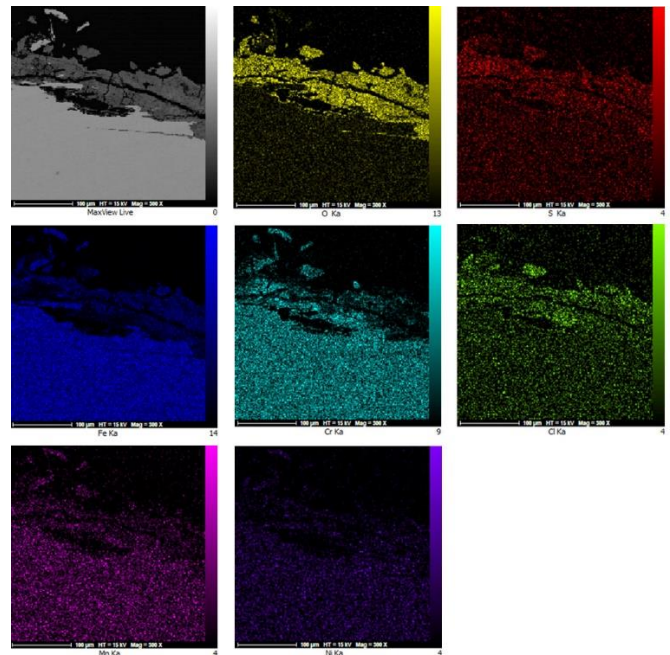
In the MAP analysis shown in Fig. 4, the presence of oxygen and sulfur corroborates the findings from previous tests.

**Fig. 4.** MAP analysis of corrosion products.

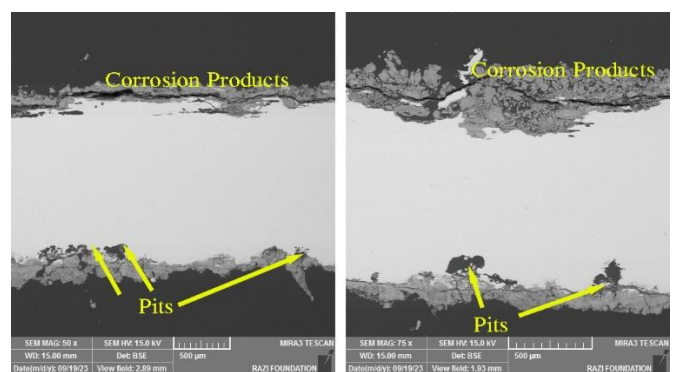
The micrographs of the samples shown in Fig. 5 revealed that both uniform and localized corrosion occurred simultaneously on the equipment body. A continuous layer of corrosion products, along with several pits, are observable in the figure.

**Fig. 5.** SEM images of the specimens showing the continuous layers of corrosion products alongside the pits.

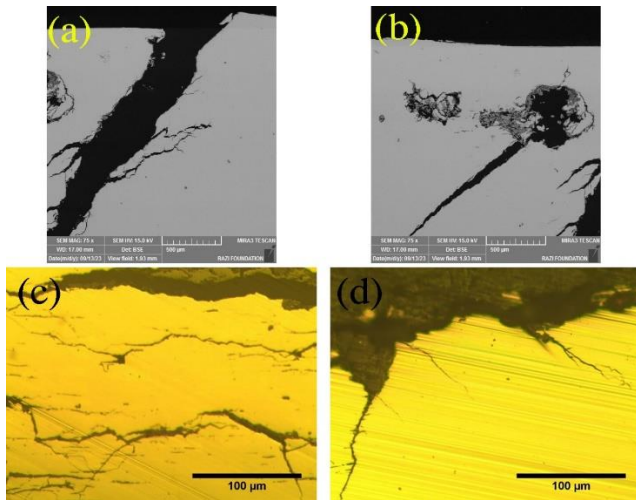
Fig. 6 shows the OM and SEM images of the equipment body. it is evident that cracks propagated from the corroded surface into the depths of the specimen, extending almost directly with multiple fine and coarse branches. These types of cracks are associated with SCC in the literature [11]. Apart from the crack initiation on the surface, a significant percentage originated

from corrosion-induced pits (Fig. 6, (b)), indicating that the pits served as stress concentration areas.

Fig. 6. (a) SEM image of the cracks initiated from the surface, (b) SEM image of the cracks initiated from a pit, (c) and (d) OM images of the cracks.

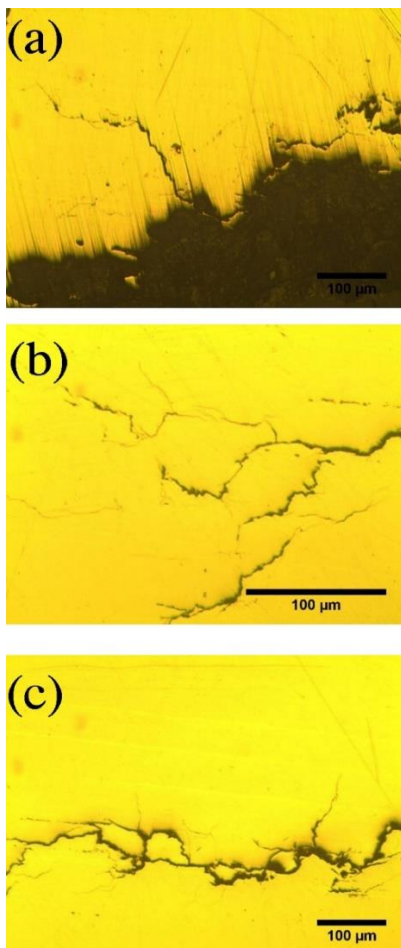
Examination of the images obtained from the OM in the welded regions (Fig. 7) revealed two major types of cracks. There are direct cracks with multiple branches (known as transgranular, Fig. 7 (a) and (b)), as well as cracks changing directions along the paths (intergranular, Fig. 7 (c)). These

cracks are the indication of susceptibility to SCC due to improper welding conditions.

Fig. 7. OM images of the cracks formed in welded regions.

The morphology of the cracks formed in welded regions (Fig. 7) demonstrates cracks propagation along grain boundaries, indicating evidence of intergranular corrosion. When austenitic stainless steels are exposed to temperatures within the range of 427–899 °C, chromium along grain boundaries tends to combine with carbon to form carbides. This phenomenon, known as sensitization or carbide precipitation, reduces chromium content and decreases resistance to corrosion in areas surrounding grain boundaries. The occurrence of this process depends on both temperature and time [20].

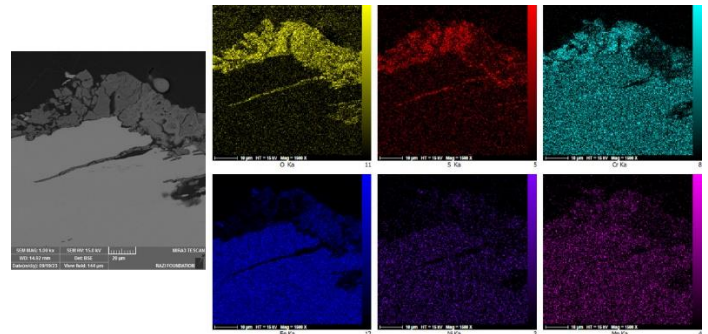
Elemental MAP analysis of the welded area (in Fig. 8) shows the presence of sulfur alongside iron/chromium oxides in the corrosion products.

Fig. 8. Microstructure and elemental analysis of welded regions.
