# Integrity assessments of steel slabs for using as a base material for manufacturing of API X70 pipes

## ABSTRACT

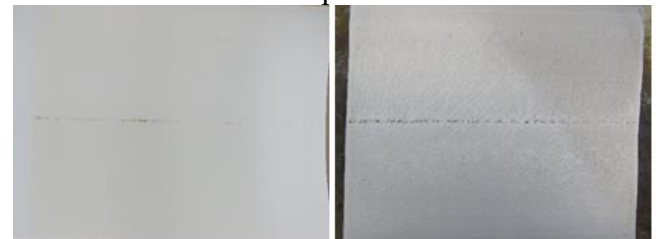
technique known as the BAUMANN test. The results of the BAUMANN test on the slabs are depicted in Figures 4 and 5. The test result reveals the presence of shrinkage holes on the slabs, as evidenced by the straight-line pattern of dotted lines on their surface.

Figure 4. Images of BAUMANN test Slab 01.

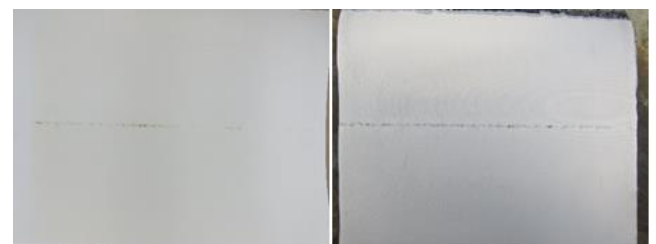
Figure 5. Images of BAUMANN test Slab 02.

3. The existence of shrinkage holes in the defect region suggests the necessity to enhance the Soft Reduction system.
4. This issue can be effectively managed by regulating the secondary cooling process, optimizing the intervals between the rollers in continuous casting, and maintaining complete control over the metallurgical length.

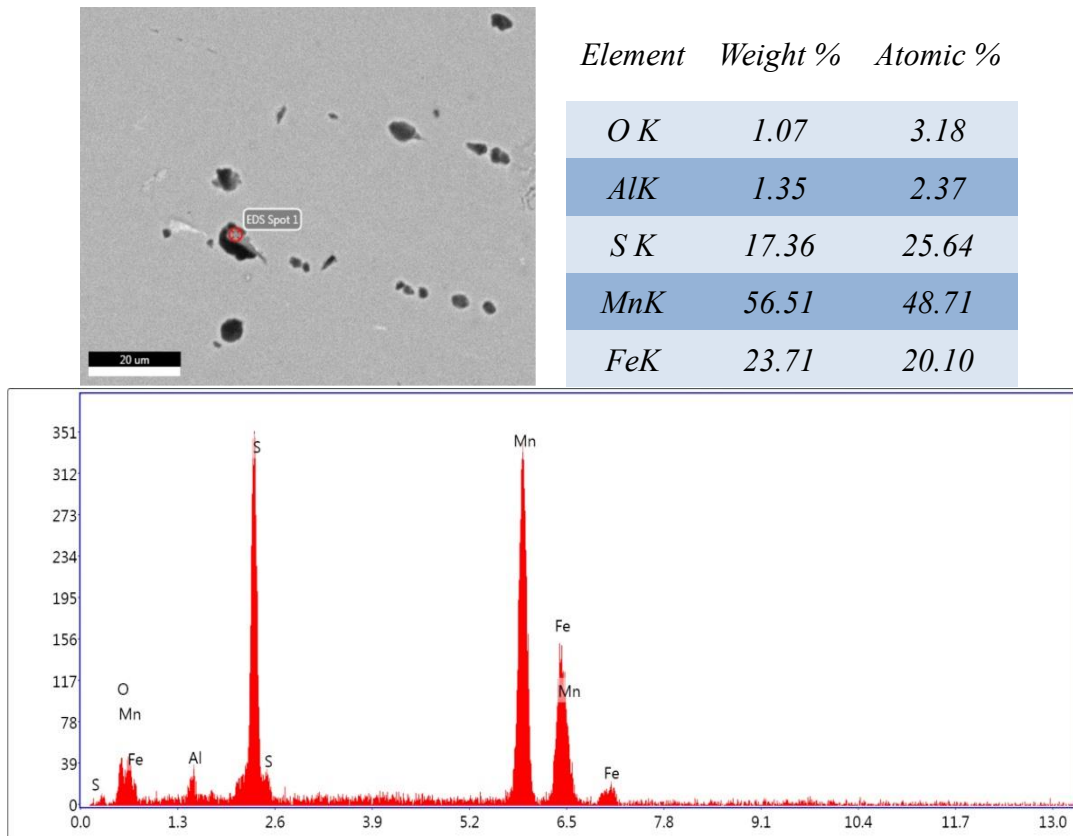
Additionally, the electron microscope was utilized to analyze the surface of sample D obtained from slab 02. Figures 14 and 15 depict the sample's surface, exhibiting impurities and shrinkage holes. Based on the elemental analysis of the impurities, which reveals the presence of sulfur, aluminum, oxygen, and manganese, it can be inferred that the impurities consist of both sulfide and alumina compounds.

Figure 14. Electron microscopy image and elemental analysis of surface impurity of sample D.
